**INTENSIVE CULTURAL RESOURCES SURVEY OF THE
HILLTOP PHASE I 23.02-ACRE PROJECT
BEXAR COUNTY, TEXAS**

SWCA Project Number 14390-224-AUS
SWCA Cultural Resources Report No. 2008-219

PROJECT TITLE: Intensive Cultural Resources Survey of the Hilltop Phase I 23.02-Acre Project, Bexar County, Texas

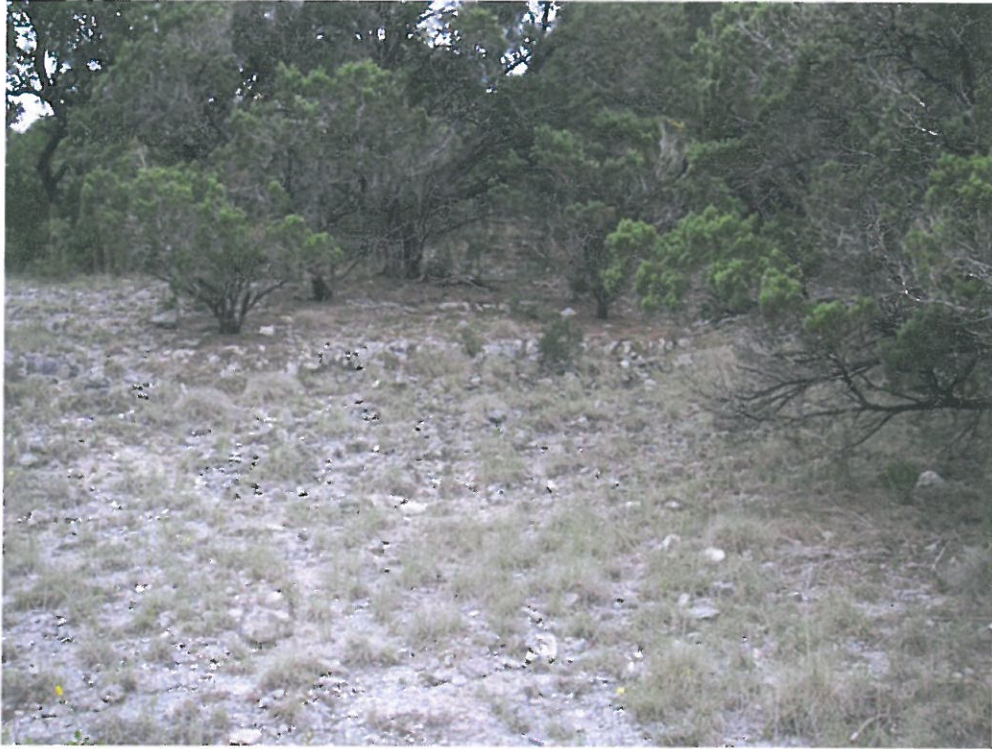
Figure 2: Overview of upland terrain with exposed stepped bedrock, facing south.

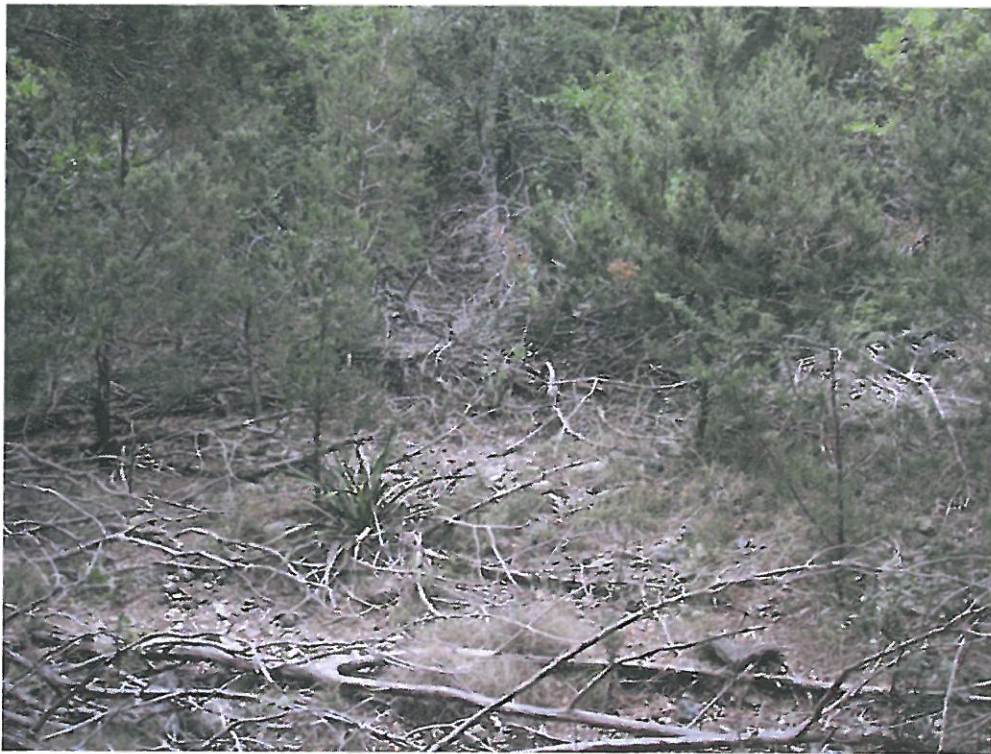
Figure 3: Typical vegetation in the project area, facing southeast.

Although the depths of impacts for the project construction have not been indicated, current construction observed near the property is over three feet in depth. The project area is situated in an upland setting positioned along the slopes overlooking small tributary drainages of Leon Creek located about 0.5 miles to the southwest (Figure 1). The overwhelming majority of the project area occupies rocky limestone upland terrain with soils of little vertical depth and broad areas of exposed bedrock (Figure 2). The project area contains thick vegetation with an overstory of a few oaks and cedar, and a dominant understory of

juniper and various shrubs (Figure 3). At the time of the survey, ground visibility within the project area ranged from a low of 35 percent to a high of 100 percent, but the visibility was typically about 70 percent.

On May 6, 2008, two SWCA archaeologists conducted an intensive pedestrian survey of the 23.02-acre Hilltop Phase I project area. Overall, the project exhibited prevalent rocky uplands and some significant modifications. Some of these disturbances include: a residence and associated outbuildings, overhead utilities, existing paved roadways (Figure 4), refuse disposal, and vegetation clearing. The project area is a mix of thick vegetation with an overstory of scattered oaks and cedar and extensively cleared areas with only shrubs and short grasses (see Figures 2 and 3).

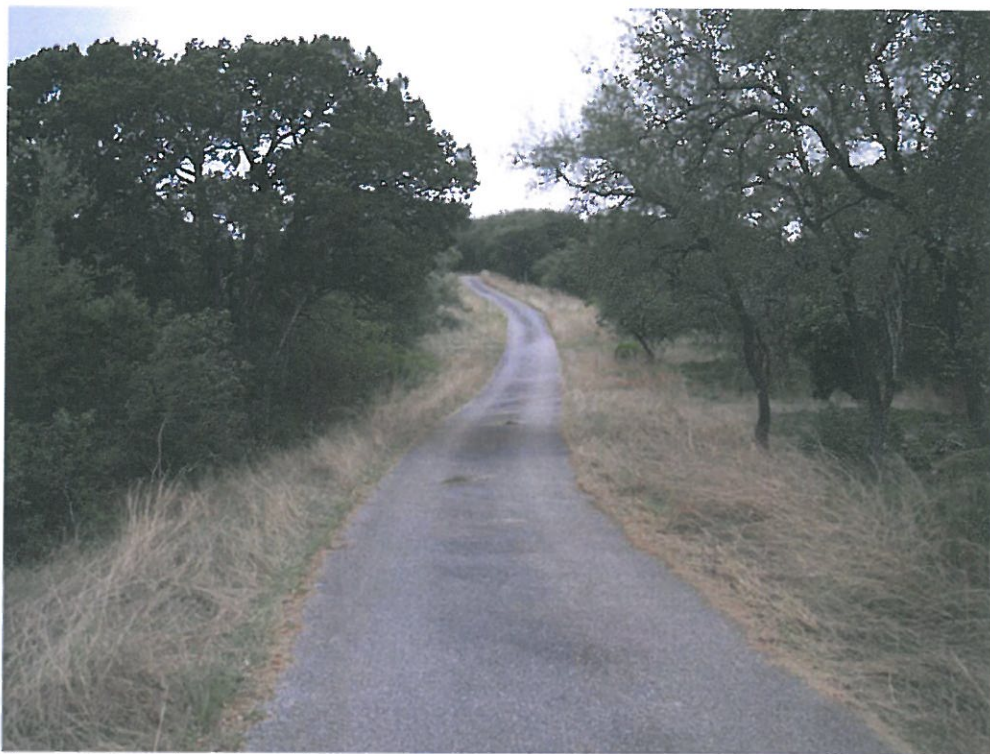
Figure 4: Paved road or driveway in project area, facing southwest. Note rise in background.

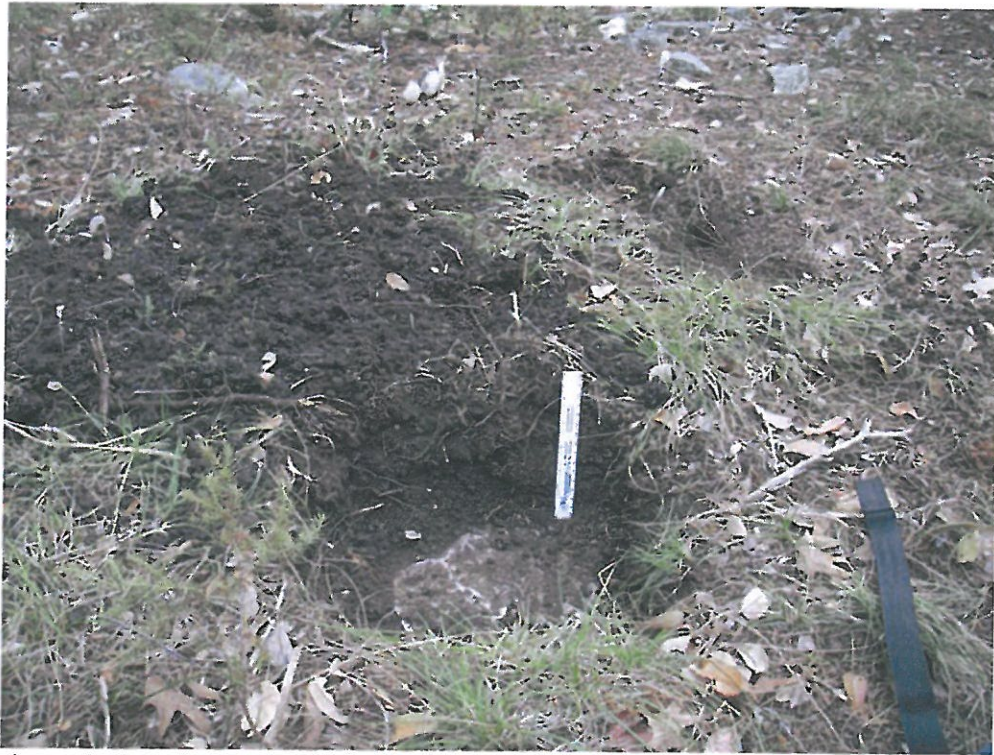
gravels and small cobbles overlying degrading limestone bedrock (Figure 6).

Figure 6: Shovel test J6, with representative shallow soils over bedrock, facing northwest. Ruler is 15 centimeters.

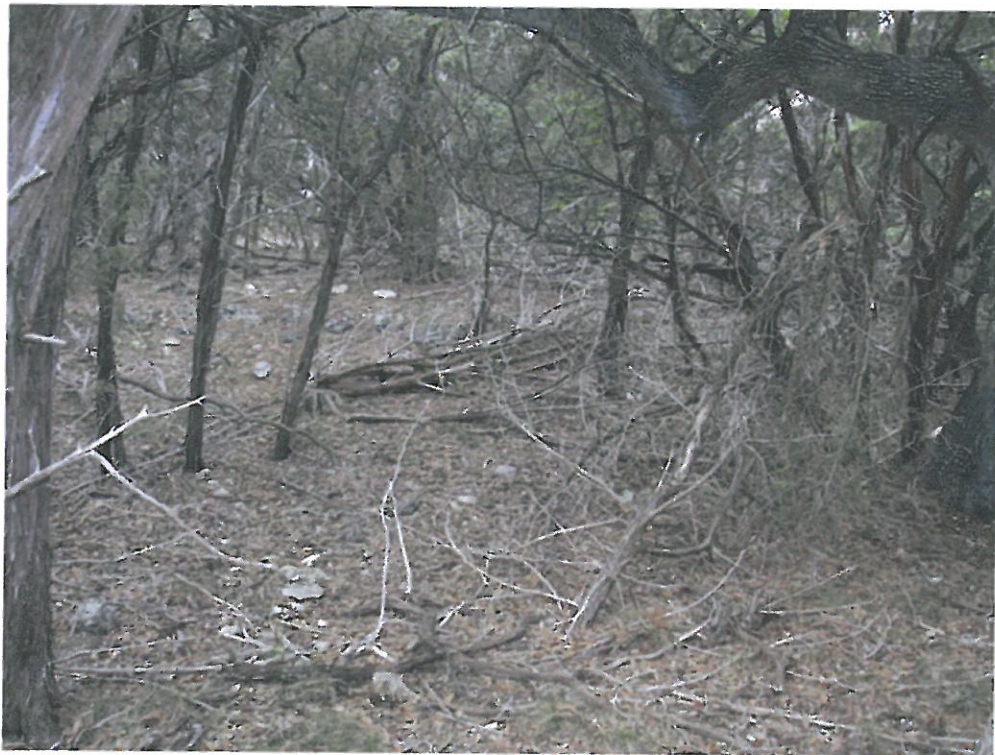
Figure 7: Representative view of slopes throughout project area, facing east/uphill.

Additional shovel tests were deemed unnecessary due to the widespread bedrock exposures, steep slopes, and scattered disturbances (Figures 7 and 8).

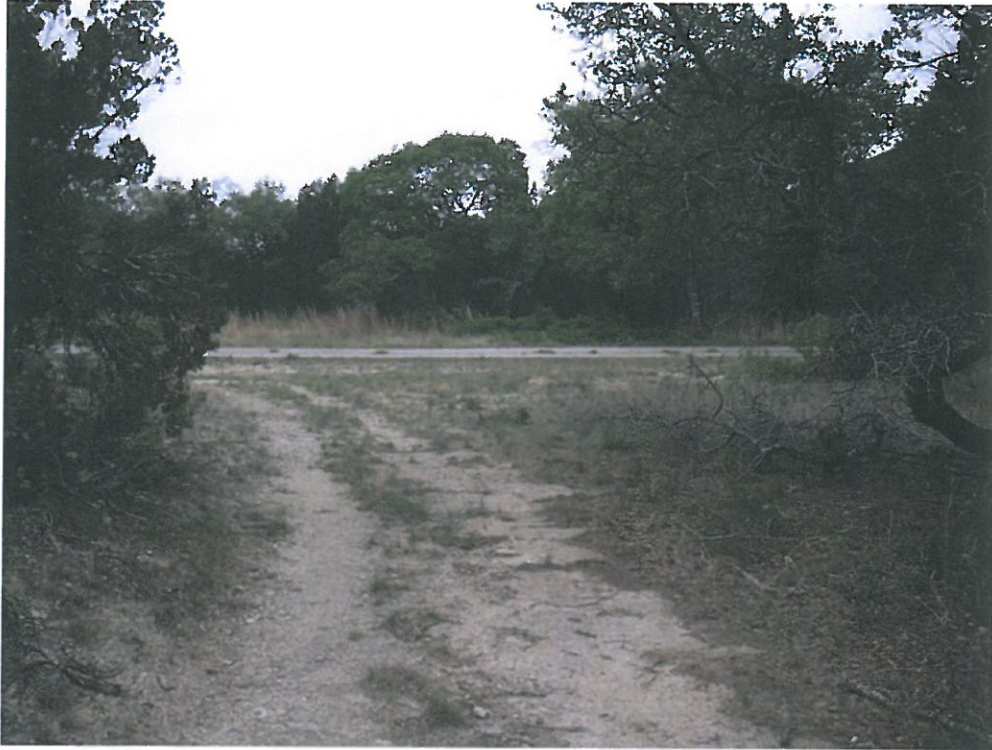
Figure 8: Disturbances from paved and two-track roads and associated clearing, facing west

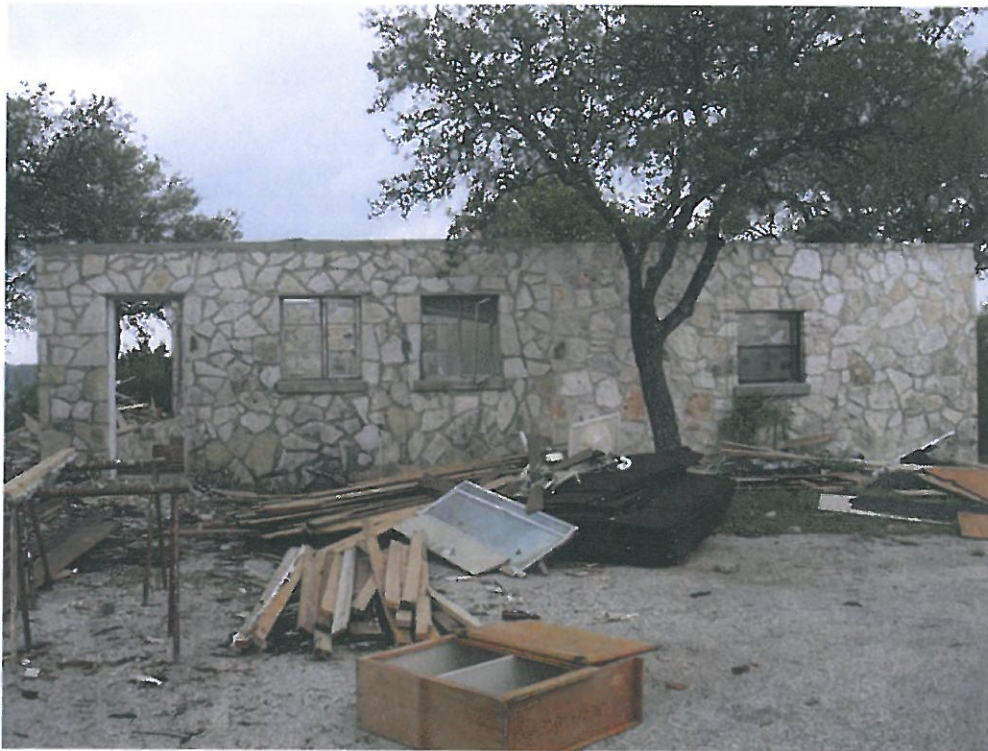
The residence (Figure 9) is located at the top of a hill, at the end of the paved driveway. It is depicted on the Camp Bullis topographic quad map (Figure 5), and is shown in the same location on the 1953 Camp Bullis topographic quad map. The front wall of the house and much of the interior has been gutted, and the roof has been removed (Figure 10). SWCA Historic Archaeologist Mindy Bonine dates the building construction to the early 1940s, based on the steel frame windows, floor foundation planking and the materials used. She

notes, however, that some of the windows have been replaced, the toilet and shower tile is modern, and modern plumbing and air conditioning had been installed.

Figure 9: Standing walls and debris associated with former residence in project area, facing west-southwest. Note original windows to left and modern window to right.

The residence is of recent historic age, dating to roughly 1941. However, one of the primary considerations in evaluating a building for National Register of Historic Properties significance is integrity. According to National Register Bulletin 15 (1991: 44), the seven aspects of integrity are location, design, setting, materials, workmanship, feeling, and association. Based on our assessment, the only aspect of integrity that the property retains is location, in that the structure is still situated where it was originally built. The current state of the building has compromised any other aspects of its integrity. Therefore, the building is not considered significant and is not considered eligible for the NRHP.

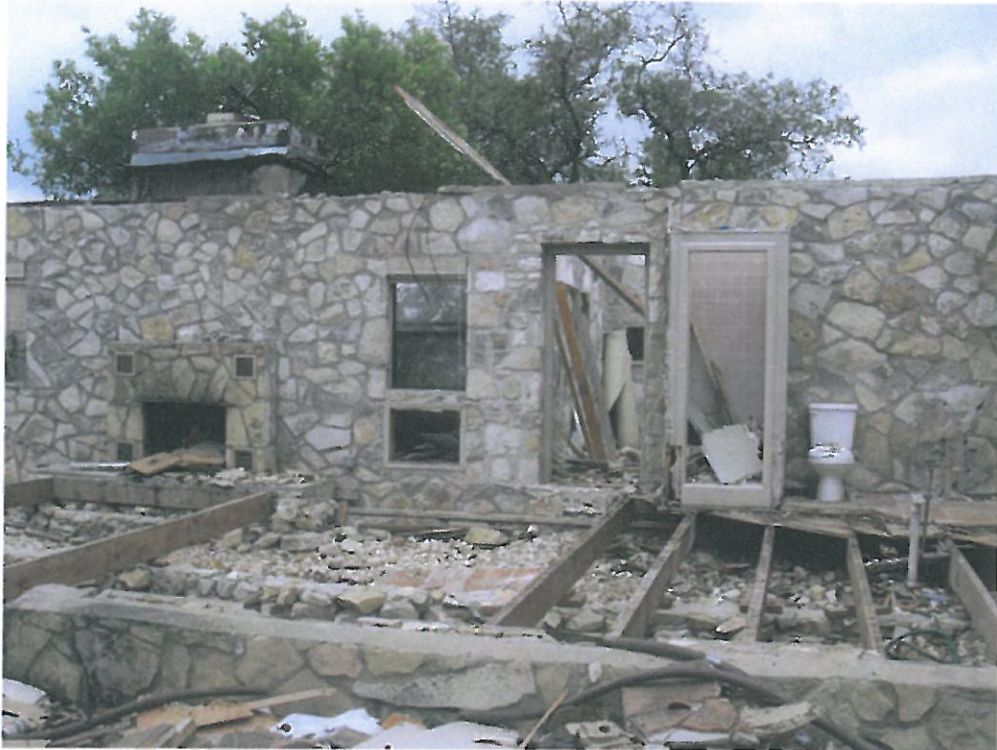
Figure 10: Interior of residence from front porch, facing northwest. Note floor foundation planking, PVC pipe to right, and modern toilet in rear.

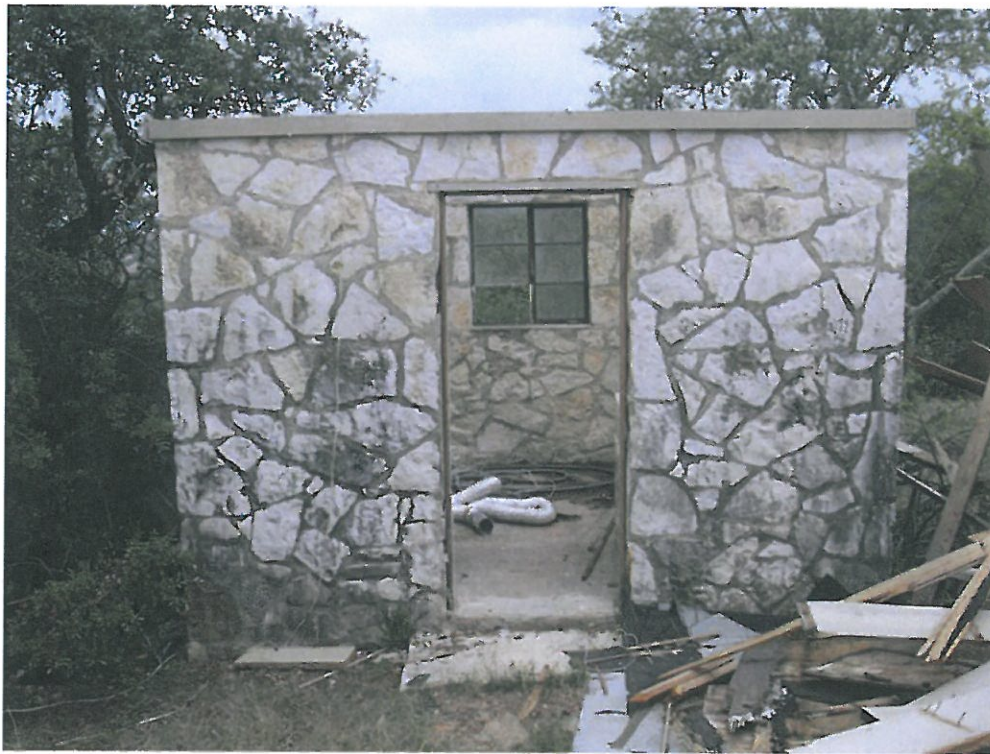
Several features related to the residential complex are also present in the project area. An outbuilding serving as a utility room (Figure 11) is located behind the house, to the north. The steel frame window and concrete floor, as well as similar construction materials, date it as contemporaneous with the house. Inside the building was a late 20th century model washing machine and two pennies, dating to 1999 and 2000. There is no roof on the building. The outbuilding is unremarkable and would only be a contributing element to the overall eligibility of the residential complex.

Figure 11: Outbuilding utility room, facing north-northwest. Note concrete floor, and original window in background.

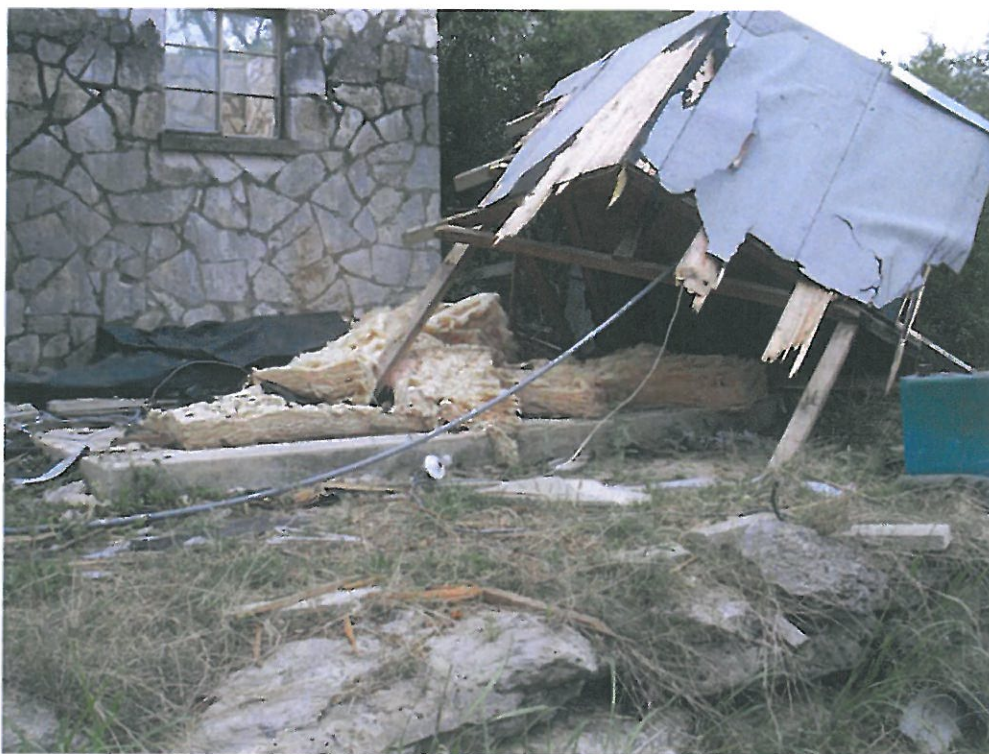
Directly behind the utility room is a collapsed pole-frame structure with a concrete foundation (Figure 12). The function and date of the original structure is unknown. To the northwest of the house, west of the utility room, is a concrete pad foundation (Figure 13). This may have been the location of a water cistern, as two modern metal cisterns were dumped next to the utility room. Neither of these features is

Figure 12: Collapsed pole shed remains behind outbuilding, facing south.

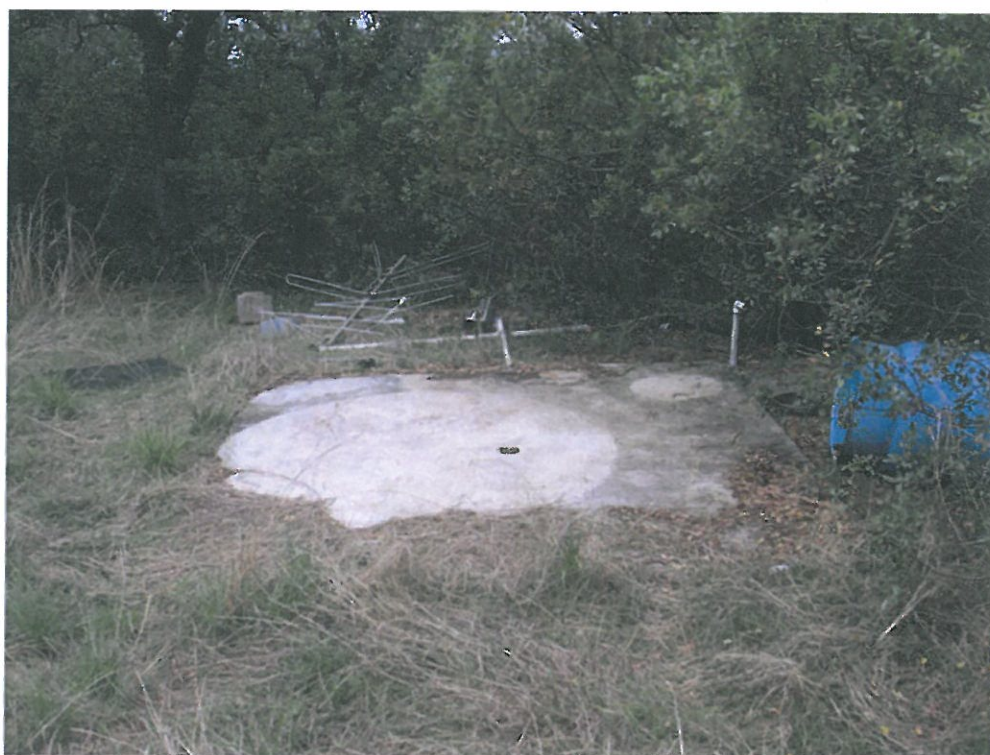
Figure 13: Concrete pad behind house, facing west-northwest.

intact, thus they do not contribute to the overall assessment of the complex.

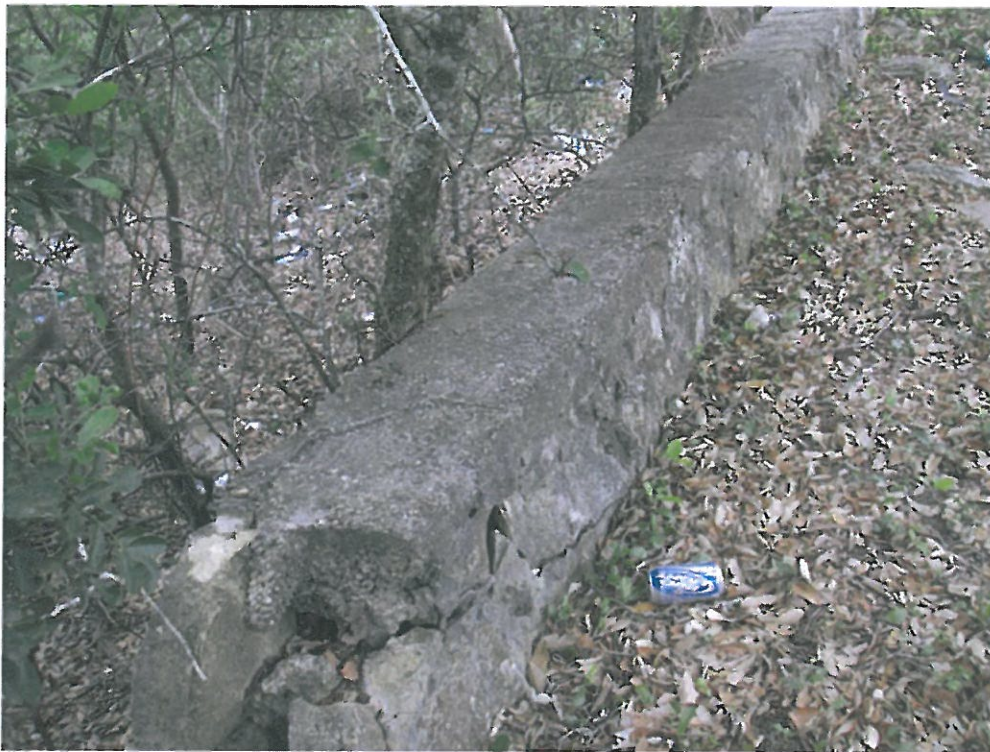
The final feature associated with the residence is a stone wall around the perimeter of the complex (Figure 14). The wall is constructed of limestone blocks and concrete mortar, and is presumed to be contemporaneous with the residence. In some areas, the wall has been damaged, but a majority is intact. However, the wall is a common type and would only be a contributing element to the overall eligibility of the residential complex.

Figure 14: Mortared stone wall surrounding house area, facing west-southwest.

Two shovel tests were excavated in the vicinity of the residential complex, including one by the driveway to the east of the house. Both shovel tests were negative for cultural materials and encountered extremely shallow bedrock (Table 1). The refuse and building debris by the house was visually assessed and determined to be from the late 20th century. Therefore, the complex is not considered to be an archaeological site. No further work is recommended for any portion of the residential complex. Additionally, no further work is recommended for the remainder of the project area.
